Mercury recovery at the Miramas site in France

Mercury recovery was a key focus of the final cleanup and shutdown of the century-old chemical plant in Miramas, France. Building demolition, debris decontamination, and soil cleanup were required to remediate the site for future industrial use.

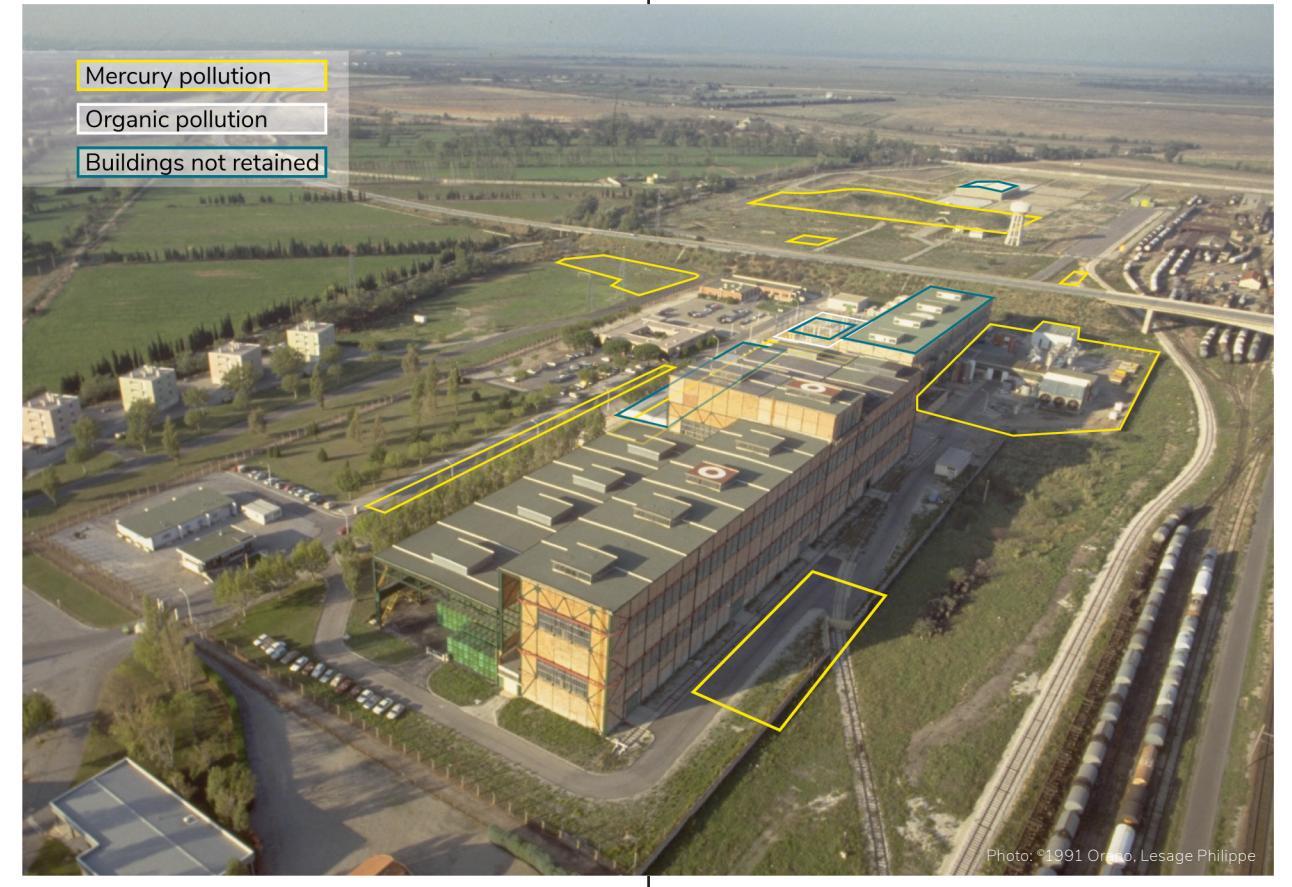
Polluted areas at the Miramas site

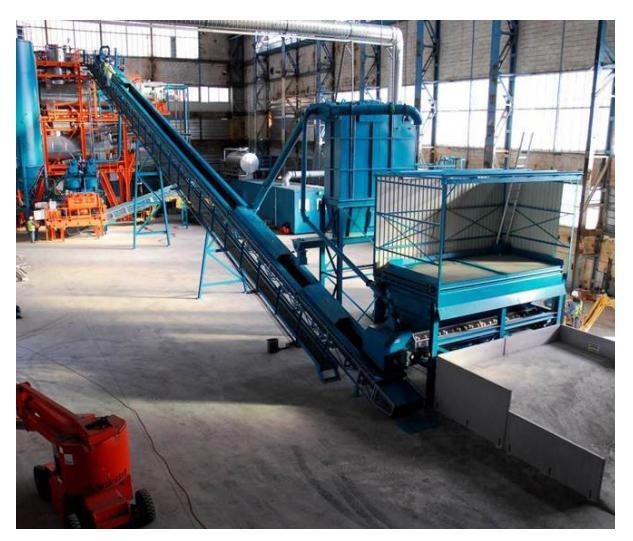
The TDU treats soil particles measuring less than one-third of an inch

- Thermal desorption process: treating excavated soil particles less than 0.4 inch in size by heating them in a large oven that captures the contamination as it evaporates. At Miramas, a thermal desorption unit (TDU) was used to treat batches of between 8 and 13 tons, at a rate of approximately 330 tons per week.
- Treatment by washing: The washing system separated the dust and fines adhering to coarser materials measuring approximately 0.4–2.8 inches. The smaller particles that contained virtually all of the mercury contamination became suspended in a washing fluid and were removed and treated, while the washing water was clarified and recycled in a closed loop.
