# McClellan Lake Environmental Monitoring Quarter Four - 2023

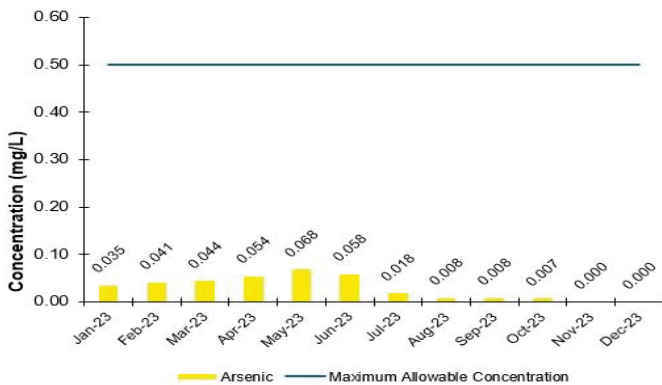
## > Arsenic in Treated Effluent

The graphs below show the differences between the regulatory limits and the sampling results from water released to the environment from the water treatment plant at the McClellan Lake Operation for the past 12 months. The bars at the bottom of each graph show the concentrations of elements in water from our water treatment plant. The lines across the top show the regulatory limits. The graphs indicate that concentrations of elements in our treated effluent are well below regulatory limits.

Please note that no values are presented for November and December 2023 as the JEB Water Treatment Plant has been temporarily shut down since October 2023 for a thorough cleaning and servicing of the facility.
